**Evaluation of the Quality of Sapphire Using  
X-ray Rocking Curves and Double-Crystal  
X-ray Topography**

1 May 1994

P. M. ADAMS  
Mechanics and Materials Technology Center  
Technology Operations

6. AUTHOR(S) P. M. Adams					
7. PERFORMING ORGANIZATION NAME(S) AND ADDRESS(ES) The Aerospace Corporation Technology Operations El Segundo, CA 90245-4691				8. PERFORMING ORGANIZATION REPORT NUMBER  TR-94(4935)-7

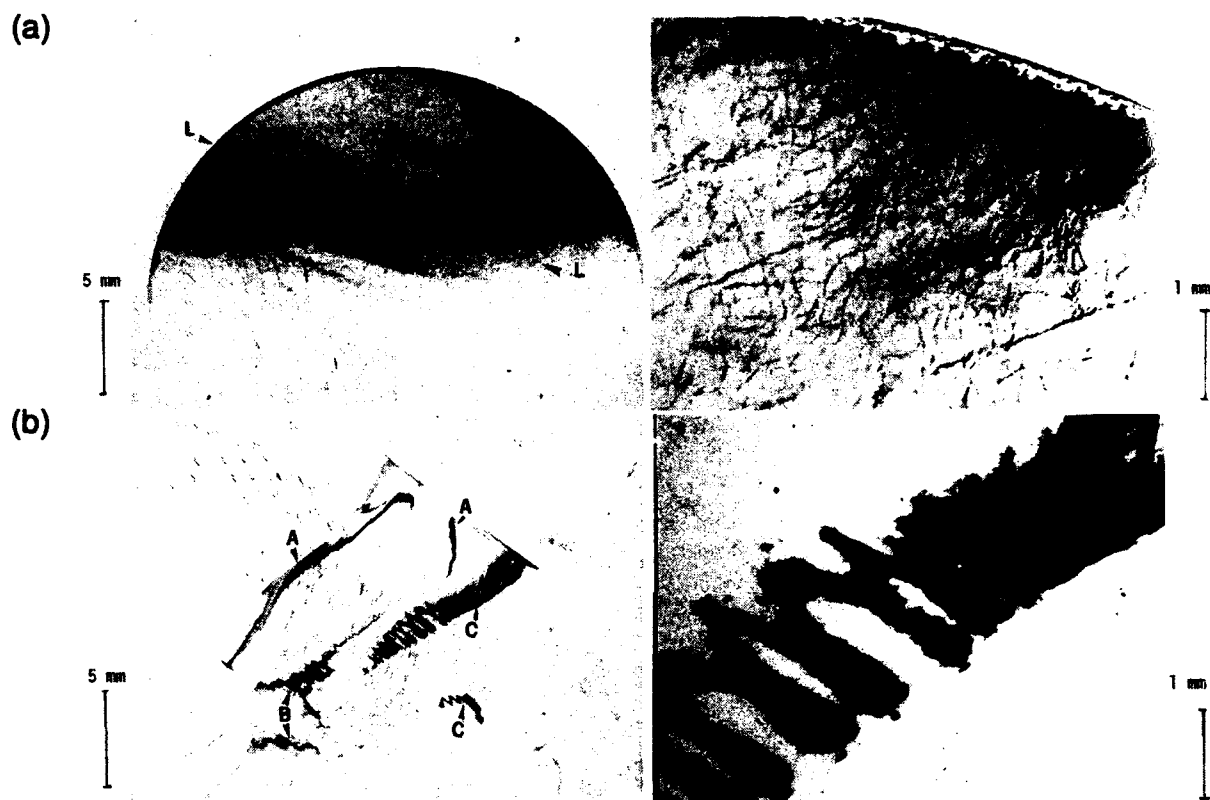
Figure 6. (119) topographs of (001) orientation substrates. (a) SOS-grade material (without Si); note dislocations (D); (b) window-grade material.

The (119) topographs of the two (001) samples are given in Figure 6. The topograph (Figure 6a) of the SOS-grade material shows a large area diffracting uniformly. Superimposed on this are frequent dislocations (D) and subtle linear (L) contrast variations, which may reflect slight variations in lattice parameter. Basal dislocations have been previously reported for sapphire.<sup>8,9</sup> Topographs were taken on three positions of the rocking curve of the window-grade sample because of the low intensities and extended angular range. The three (A-C) superimposed images are given in Figure 6b. Very irregularly shaped areas are diffracting at any one position on the rocking curve, and these are separated by large areas that are completely out of the diffracting condition. This is consistent with the large lattice misorientations and warpage indicated in the rocking curves. The almost helical-appearing images (C) are particularly interesting. Helical dislocations have been observed<sup>9</sup> as a result of dislocation interaction during annealing, but these are usually much smaller (100–500  $\mu\text{m}$ ) in size. The observed features may be large helical dislocation networks, but this has not been confirmed since the overall poor quality of the material does not make it suitable for its intended application.
